SITE REPORT · OCTOBER 2026

# Riverview Business Center

Inspection Date: October 26, 2026

Routine Monthly Site Visit

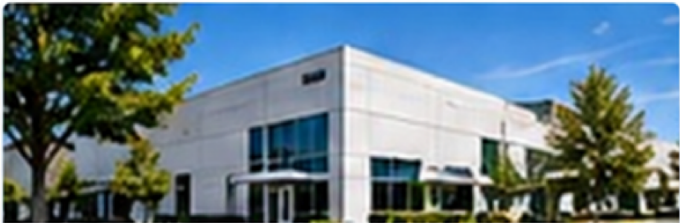
07 · Front elevation  
No new visible concern

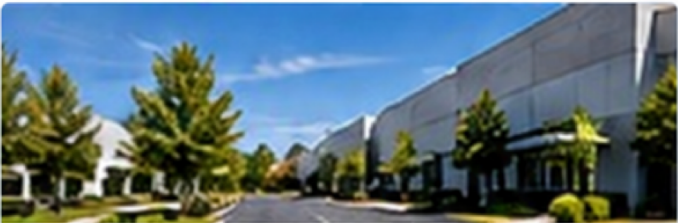
08 · Parking area  
Striping and general condition

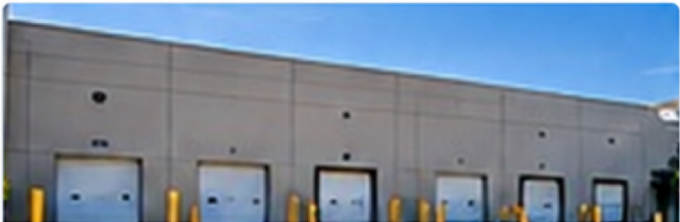
09 · Loading docks  
No new visible concern

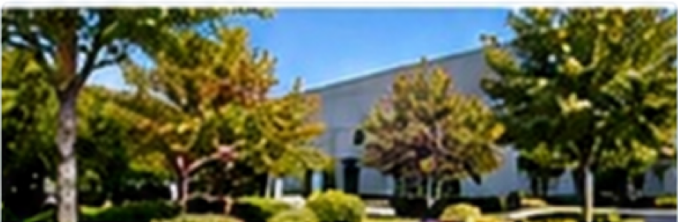
10 · Landscaping  
Appears maintained

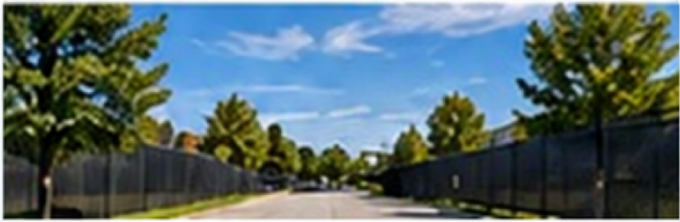
11 · Perimeter / side yard  
Access and fence line

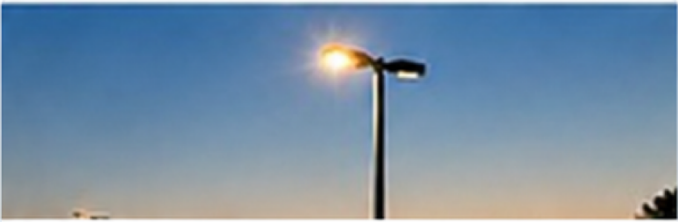
12 · Exterior lighting  
Supplemental evening reference
